24 SUPERIOR COURT OF THE STATE OF CALIFORNIA
25 FOR THE COUNTY OF LOS ANGELES

26 Case No. **20STCV22690**
27 **COMPLAINT AND DEMAND FOR**
28 **JURY TRIAL**

SOUTHERN CALIFORNIA EDISON
COMPANY, a California Corporation,
and DOES 1-100 inclusive,

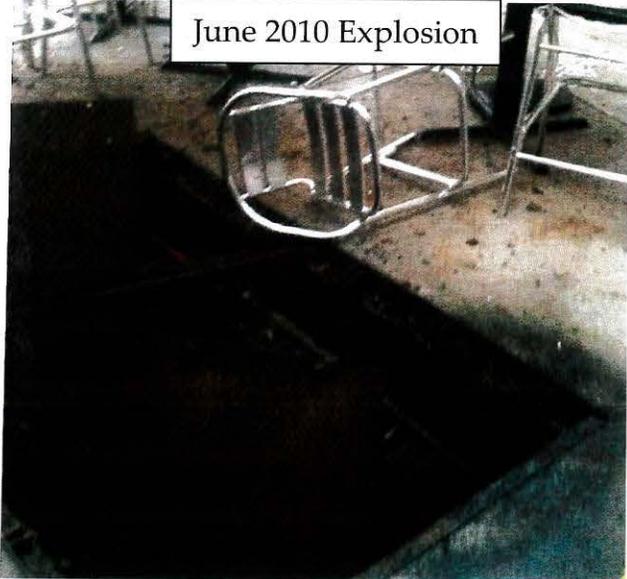
June 2010 Explosion

- **June 22, 2010** - The underground transformer vault *exploded* and caused fire damage, depicted at right. Thankfully, the restaurant was closed and no one was injured. SCE did not replace the transformers following the explosion.
- **October 17, 2015** - Bernie notified SCE that he smelled burning and smoke near the transformer on the patio.

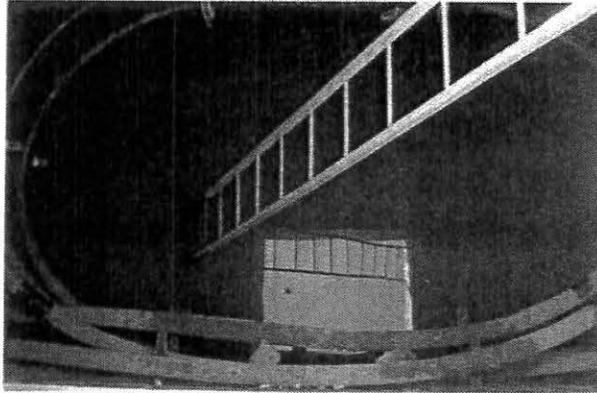
Picture 1 - A vault with what appears to be muddy water and must be tested prior to evacuation, in cases of severely contaminated water, such as this, water needs to be pumped out via a vacuum truck and sent for proper disposal. This results in additional time and resources that must be committed before electrical crews can enter the structure to begin service restoration.

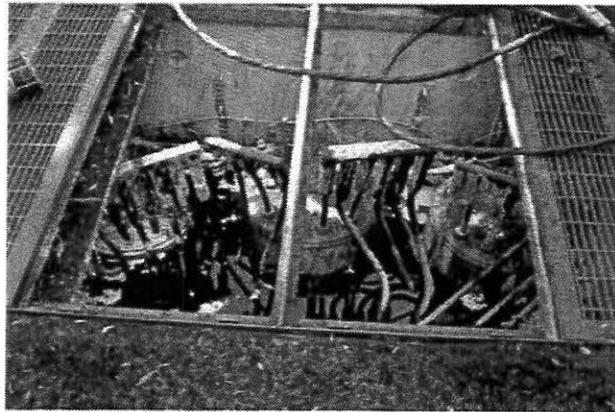
Picture 2 - Example of contaminated water that will have to be evacuated and the structure power-washed before any work can be performed on the equipment.

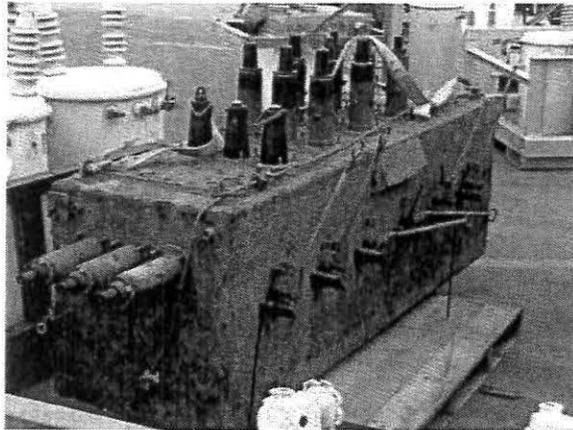
Picture 3 – An example of a switch installed in below-ground vault that failed due to prolonged submersion under water that accumulated in the underground structure.

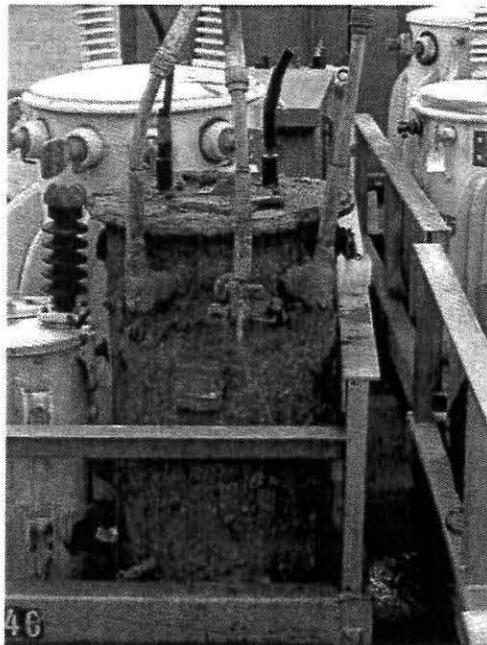
Picture 4 – Another example of a transformer that failed due to severe corrosion on the casing of the transformer. This transformer was installed in an underground structure that was also filled with run-off that collects various chemical and undesirable contaminants.

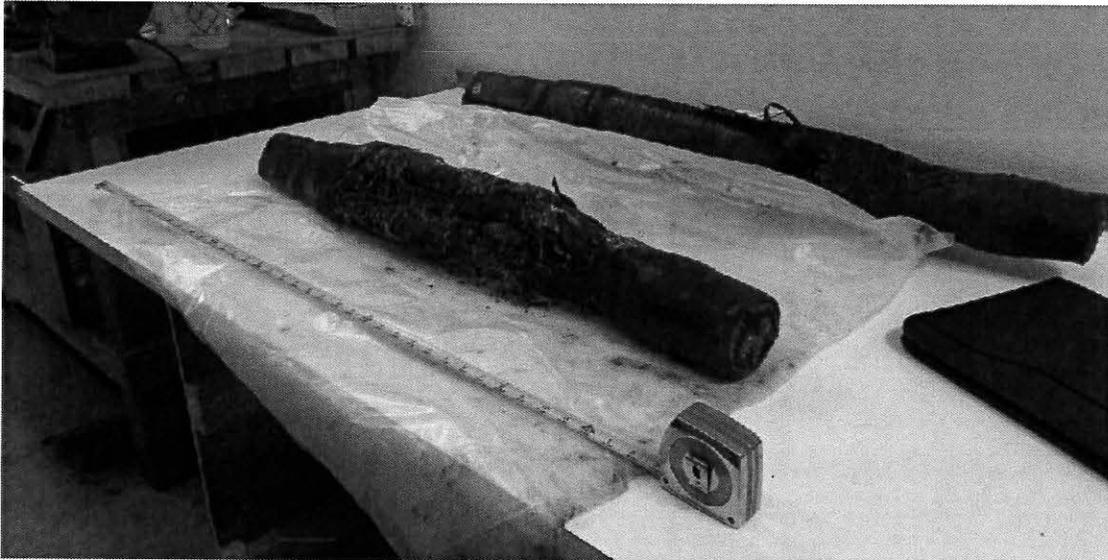
Figure 6: Float 12kV (front) and Steam 12kV (rear) PILC splices. Source: CPUC

The precipitating event for the July 15, 2015, outages was insulation degradation and ignition of the Float 12kV Paper Insulated Lead Cable (PILC) splice. The splice failure also contributed to the accelerated and premature failure of the Steam 12kV PILC splice, as they were located in the same vault. The fire or electrical arcs from the Float 12kV PILC splice caused collateral damage to the Steam 12kV PILC splice. The failures of the Float and Steam 12kV PILC splices caused their respective circuits to relay and lockout,⁶ ultimately de-energizing the circuits and significantly reducing the number of network protectors available to regulate and protect the network system, as well as interrupting power to SCE's radial network customers that are served by the Float and Steam 12 kV circuits.
