24 SUPERIOR COURT OF THE STATE OF CALIFORNIA
25 FOR THE COUNTY OF LOS ANGELES

26 Case No. **20STCV22690**
27 **COMPLAINT AND DEMAND FOR**
28 **JURY TRIAL**

SOUTHERN CALIFORNIA EDISON
COMPANY, a California Corporation,
and DOES 1-100 inclusive,

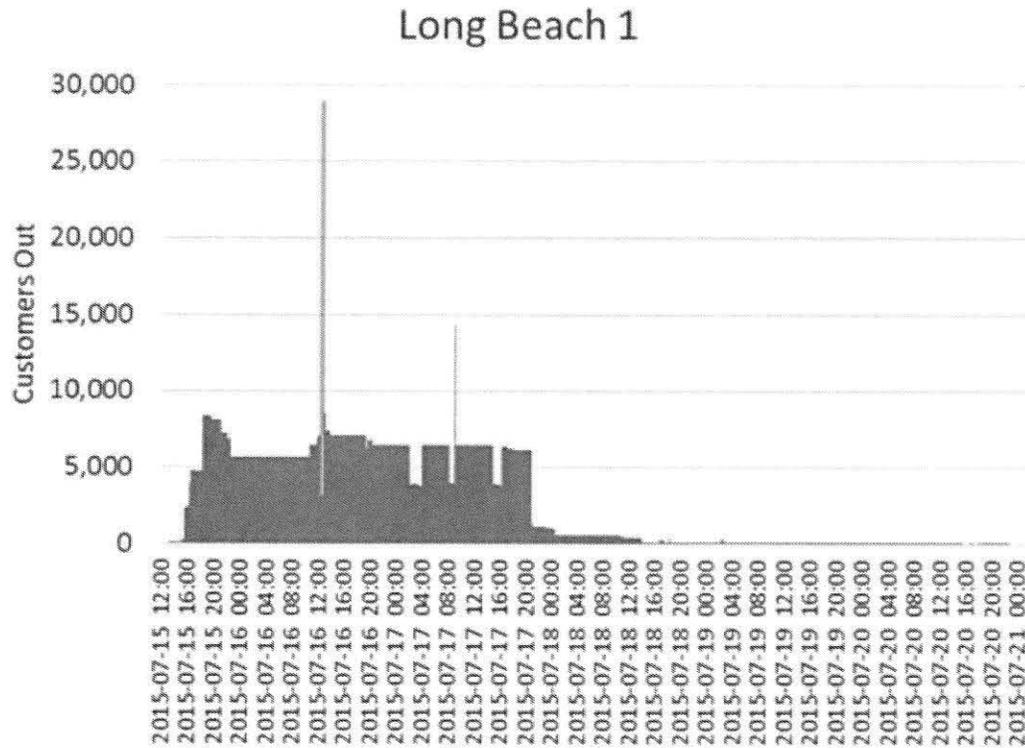
Figure 7 below depicts the Long Beach 1 outages (the number of customers who were without power at different times and dates during the outages of July 15 to 20, 2015).

Figure 7: Number of customers out by date and time for July 15-20, 2015 outages. The large spikes in the customers out of power are due to SCE shutting off primary feeder circuits for troubleshooting purposes, causing outages to radial customers. The small customer outages after 20:00 hours on July 18, 2015, represent repairs and restoration activities for the final few customers. *Source: Davies Consulting.*

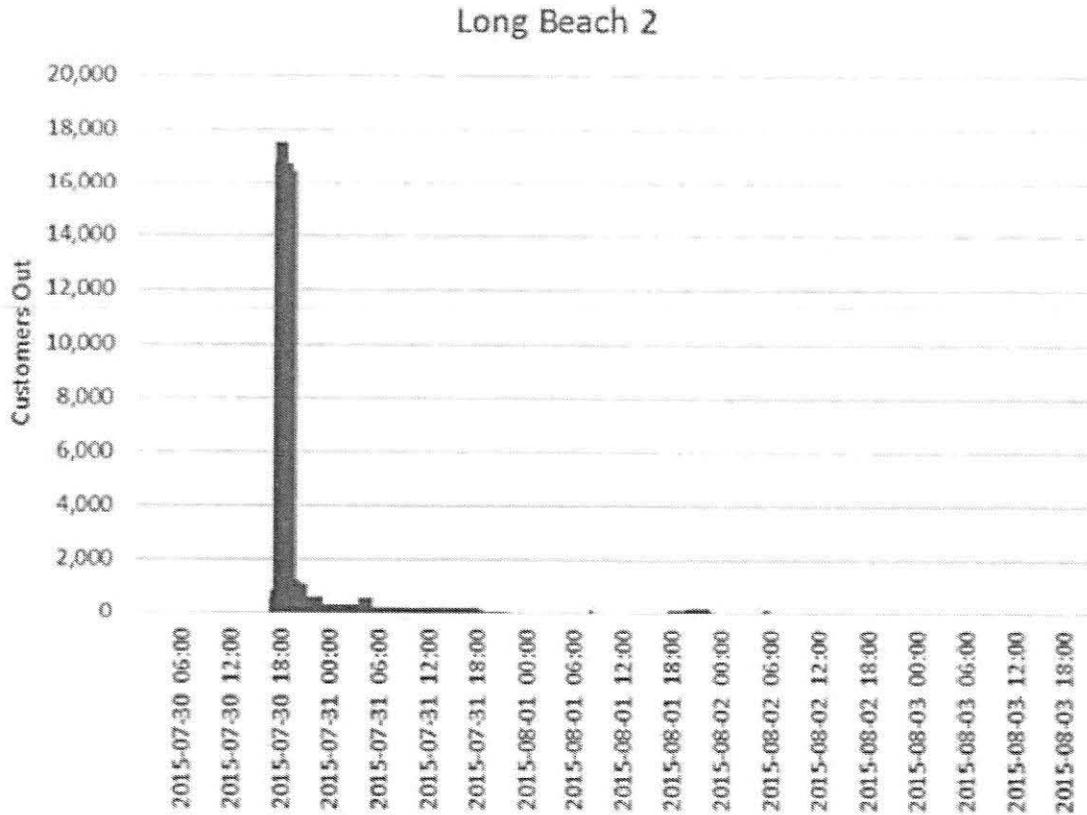
Figure 8 below depicts Long Beach 2 outages (the number of customer who were without power at different times and dates during the outages of July 30 to August 3, 2015).

Figure 8: Number of customers out by date and time for July 30-August 3, 2015 outages. The small customer outages after 00:00 hours on August 1, 2015, represent repairs and restoration activities for the final few customers. *Source: Davies Consulting.*
